Repair and Service of Turbomachinery

TON BÜCHNER SULZER TURBOMACHINERY SERVICES

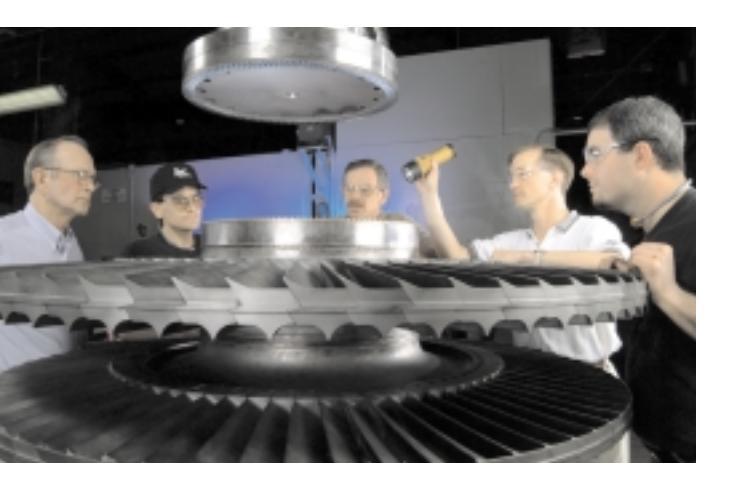
1 Hickham Industries and also the other companies of Sulzer Turbomachinery Services repair the turbomachinery of various manufacturers. The picture shows the rotor of a hot gas expander for which the repair work was completed on an emergency basis at the end of November 2000.

In November 2000, Hickham Industries Inc., a subsidiary of Sulzer Turbomachinery Services (Fig. 1[■]), received a call from one of the largest producers of electricity in the USA. It concerned a failure in the power unit of a hot gas expander serving one of their plants in Oklahoma. The machine had to be brought to the Hickham repair facility in La Porte (Texas), where the repair was undertaken on an around-the-clock basis. Five weeks later, the expander was returned to Oklahoma, where it has been operating without any problems ever since and, in fact, is running better than before. According to the customer, the The rotors of turbomachinery are subject to the most severe conditions, e.g. high temperatures. Sulzer Turbomachinery Services can repair rotors and the other components of turbomachinery even in the most difficult cases, which is undoubtedly more cost-effective for customers than replacing them anew.

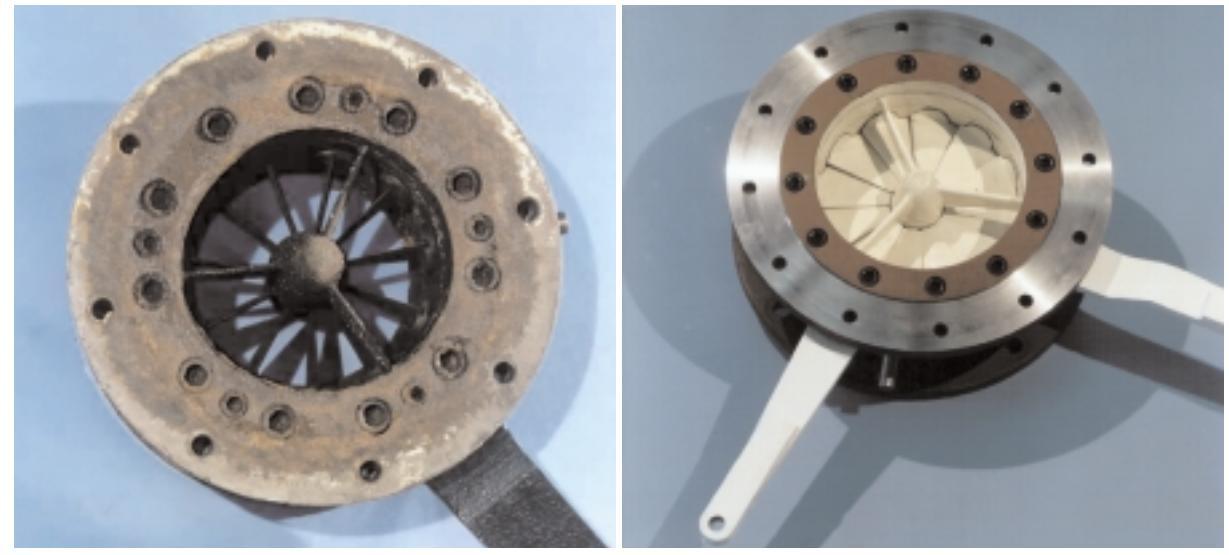
2[■] Fast repairs are one of the major requirements of customers. The bullgear compressor from which these inlet guide vanes stem (left prior to, right after repair with new coating) were repaired by Sulzer Repco within a period of seven weeks in mid-2000, five weeks faster than the offer made by the original manufacturer.

An example: Sulzer Repco received a contract in mid-2000 for the repair of a bullgear compressor which had had run for a too long period and therefore had quit a lot of damage. The OEM had quoted a repair time of twelve weeks, which was too long for the customer. Sulzer Repco was able to complete the work within a period of seven weeks. For this, extensive repair work was carried out in the Sulzer Repco workshop near Rotterdam. The compressor was provided with new bearings, which were reversed engineered according to the original design. Furthermore, a number of parts were provided with a special coating to protect them against possible friction (Fig. 2[®]).

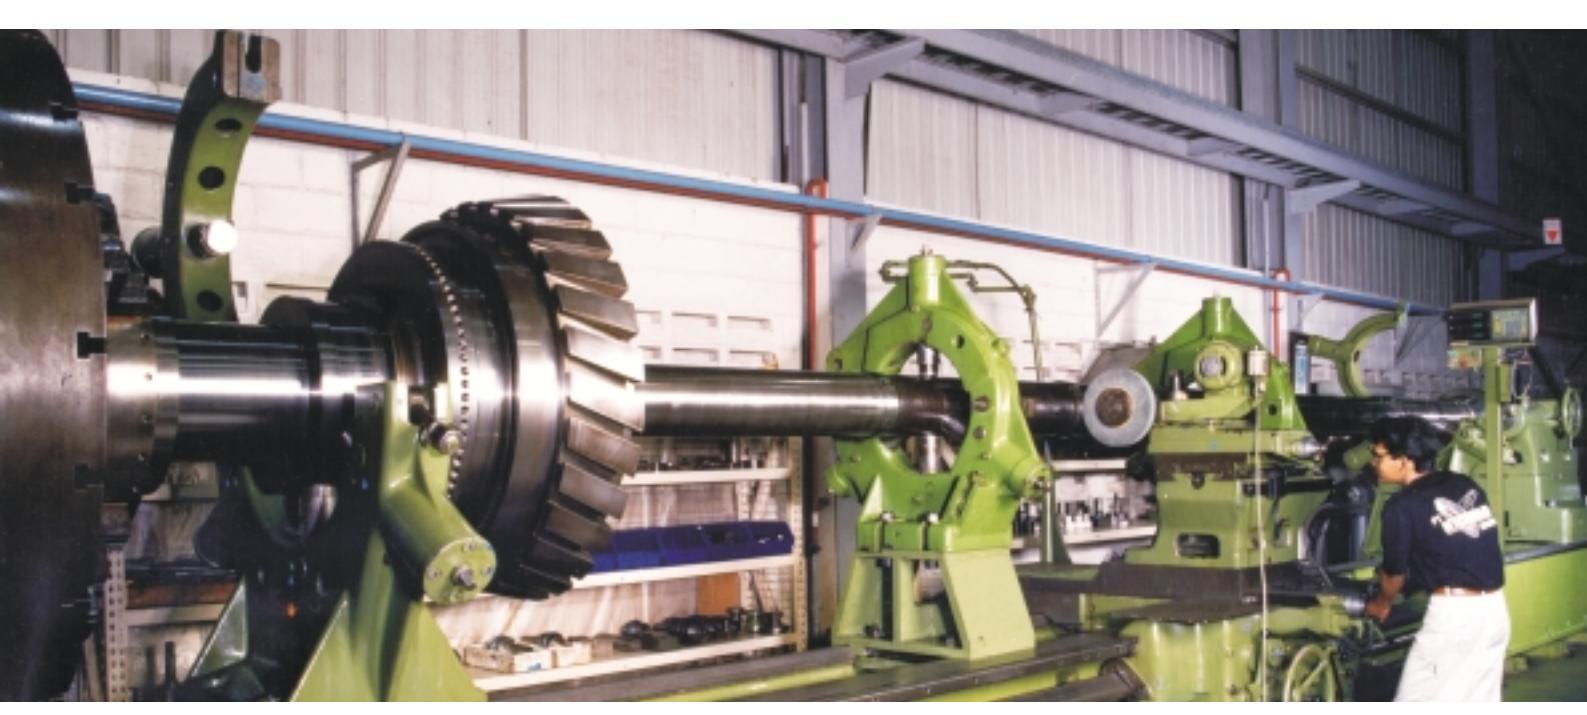
3[•] Comprehensive repair know-how facilitates high-class quality repairs. At PT Hickham Indonesia, for example, parts of the rotor shaft are treated with a special coating process, which makes them more resistant to wear.

In accordance with the contract, the repair work had to be completed and the rotor returned to Sumatra within 28 days. A further reason why PT Hickham Indonesia could win this contract is its special repair know-how. Some parts of the rotor shaft are especially subject to wear, because they are used to dampen transient vibrations when the turbine is starting up or shutting down. The conventional method of repair is to grind the affected parts undersize and manufacture new friction damper

sleeves called damping cones. This process, however, has its limitations. PT Hickham Indonesia has developed a solution with which these areas are provided with a special HVOF coating. This process creates a very wear-resistant surface and can be repeated as frequently as required.

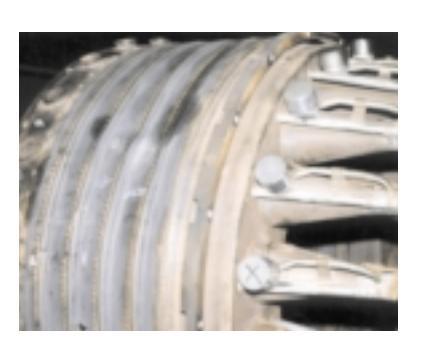
4 Elbar – a specialist for the repair of gas turbine components – has developed a unique method for the repair of combustor assemblies.

In 1999, Elbar was requested by several customers to develop a method that would enable the combustor of a specific type of gas turbine to be repaired and prolong its life cycle (Fig. 4[■]). This component is produced as a welded assembly of a carbon steel support ring, austenitic stainless steel burners and body made of nickel-base alloy. The vibration during the combustion process may also cause fatigue failures in the most robust materials, and can normally be repaired. For this, the base material properties and dimensional integrity have to be restored. With the repair method developed by Elbar, the inner walls of the combustor are provided with a zirconium

coating which serves as a thermal heat barrier, before the components are reassembled again. Results show that this repair method doubles the lifetime of the components.
